Cladding, Window and Door Replacement

# 450 SUNSET DRIVE, ST THOMAS, ON

## Project Background

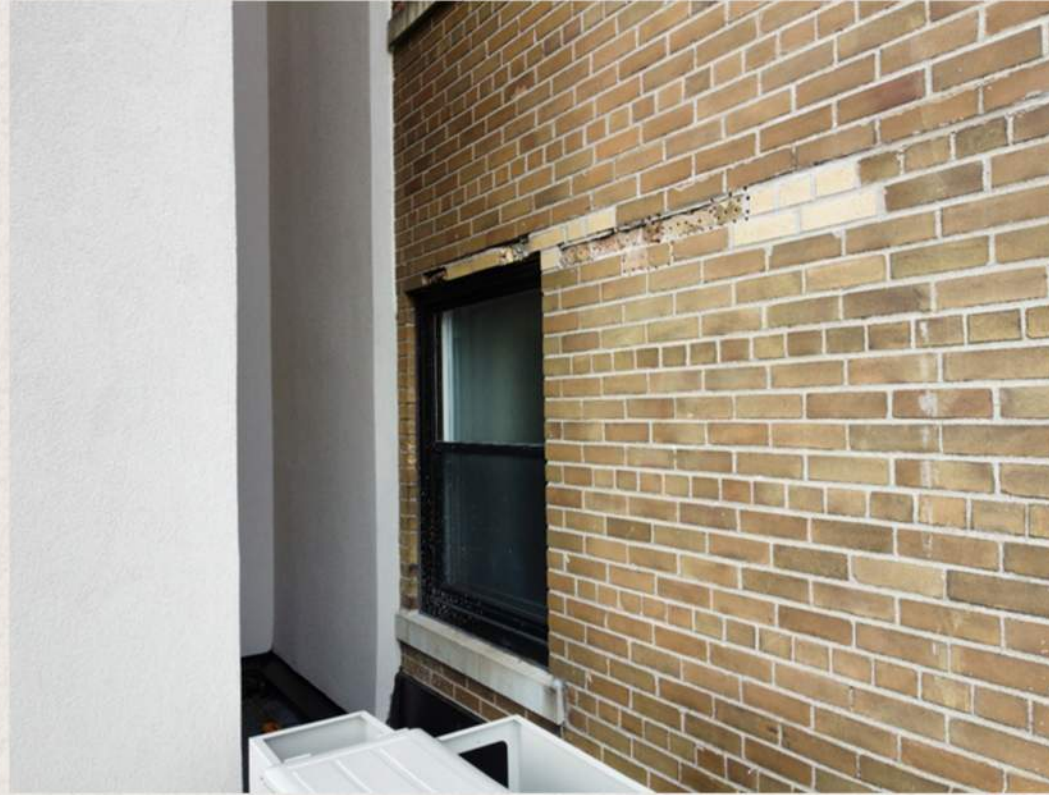
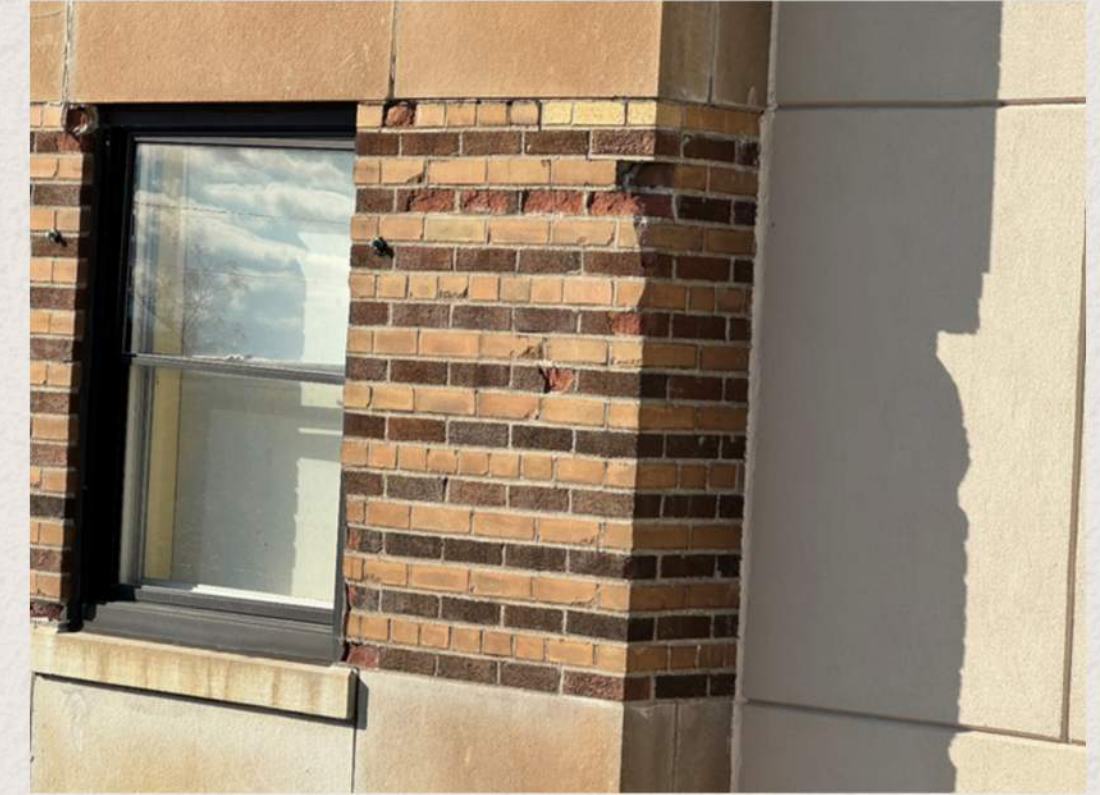
- Widespread brick and mortar deterioration is observed throughout the exterior cladding, most notably at the upper floors.
- Photos 1 & 2 show examples of spalled bricks. This type of deficiency is typically a result of repeat freeze-thaw cycles, moisture in the brick and/or long-term exposure to UV radiation.
- In photo 3, a typical view of a cluster of open and weathered mortar joints is shown. Repointing is required to secure loose bricks and prevent free water from entering the wall.
- A general observation outlined in photo 4 highlights differing drainage methods of the brick wall. Multiple repaired areas were provided with weep vents to allow moisture to drain from behind the brick to the exterior. Whereas the original brick wall is faced sealed with no available drainage path.

- The brick masonry (upper floors) has been repaired numerous times since the buildings original construction. The majority of the bricks are broadcasting failure modes of cracking and spalling. Steel lintels above windows are showing signs of corrosion and are in need of replacement. The existing wall assembly does not have an air and vapour barrier (AVB) membrane, which has a negative impact in the building's energy efficiency. To provide an AVB membrane, the brick masonry layer is to be removed and a new cladding option is to be installed.

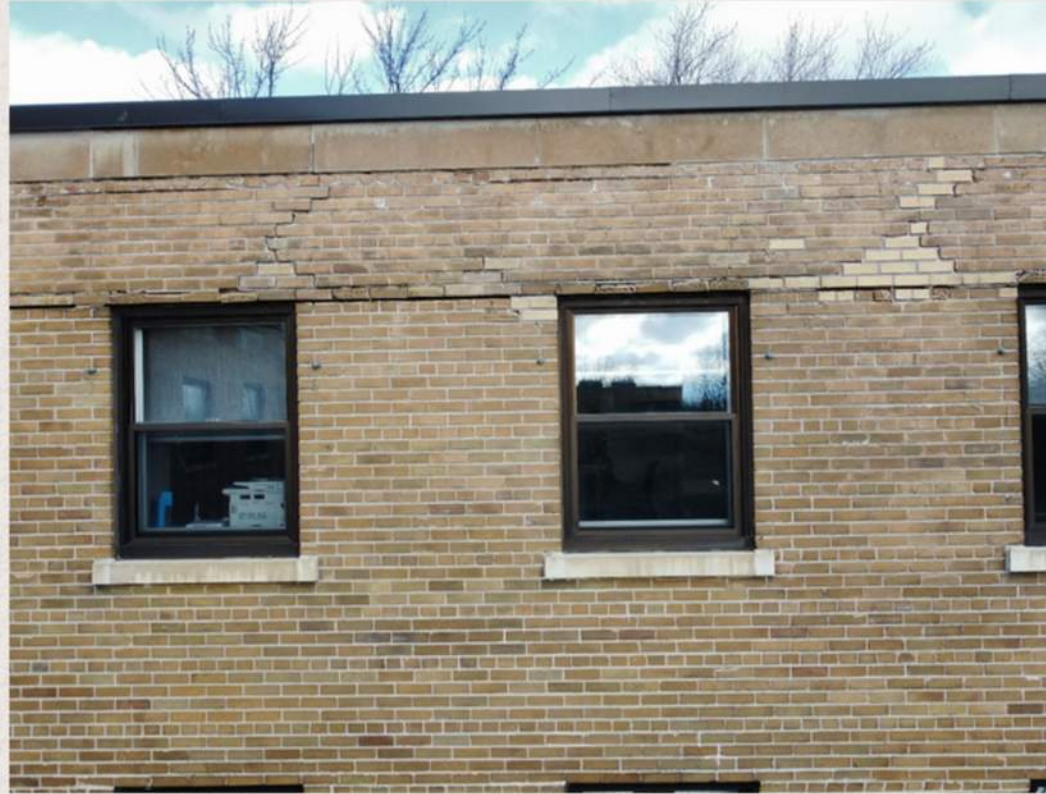
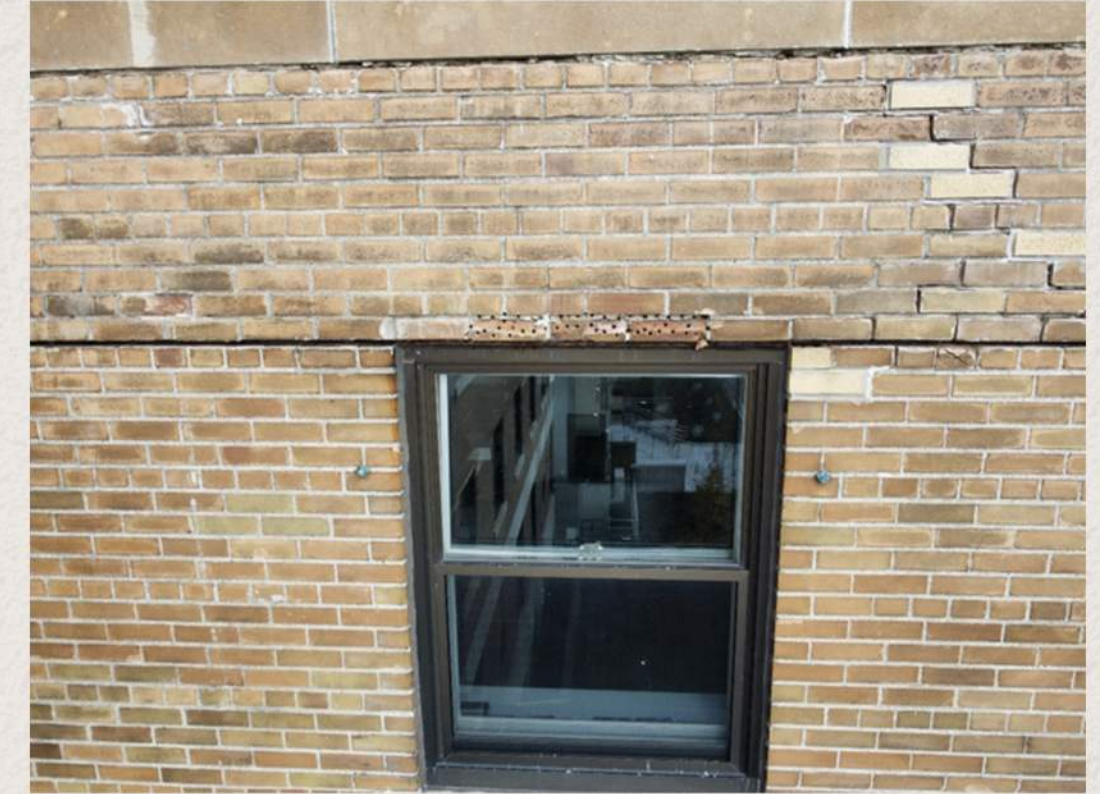
- Photos 5 & 6 show examples of deteriorated mortar joints and spalled brick. As well as a horizontal line in parallel with the windows steel lintel, caused by rust jacking.
- Photos 7 & 8 show a close up view of a typical window steel lintel at the building.
- The steel lintels are expanding due to the formation of rust (rust jacking) resulting in cracked bricks and mortar joints.
- The steel lintels were also noted to be deflecting, indicating a potential reduction in their structural capacity.
- No protective moisture barrier was noted to be installed on the top of the steel lintels.

- The stone masonry at the ground floor is in good condition; however, the steel lintels above the windows are showing signs of corrosion and are in need of replacement.

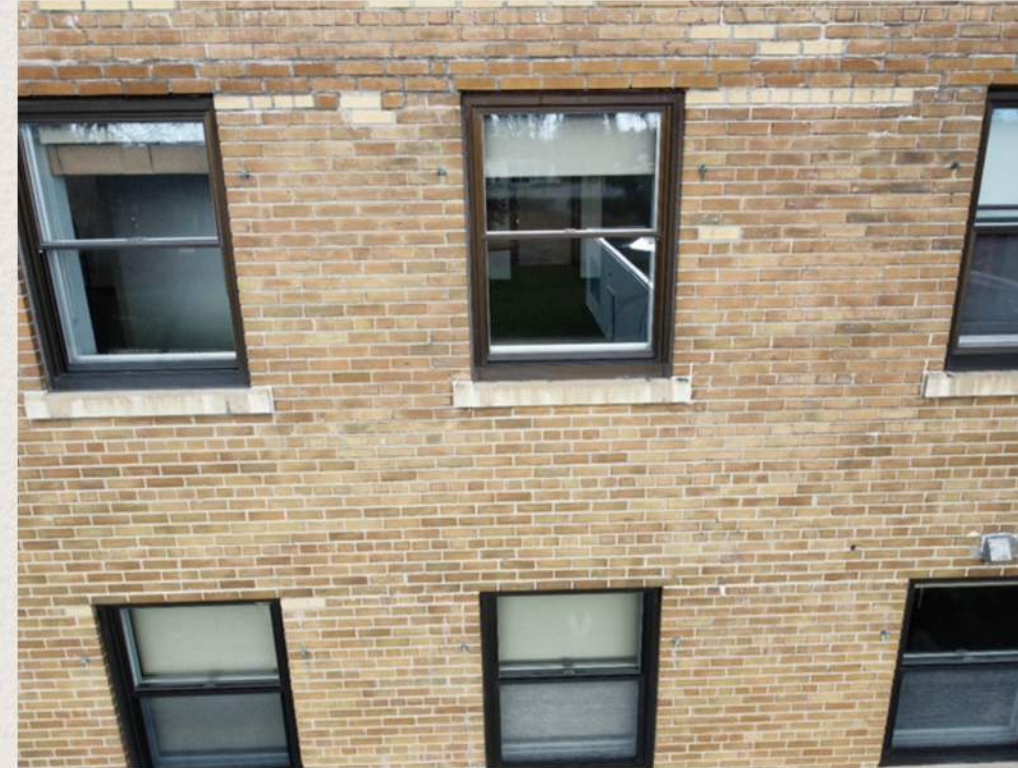
- The windows are 41 years old and are showing signs of failure such as loss of insulating properties between the windowpanes, leaking seals and aging mechanisms resulting in difficulty opening and closing operable windows.
- Photo 9 shows the typical existing windows are aluminum frame, single pane with no coating. This window type has poor insulating properties in comparison to modern assemblies, which causes an inefficient thermal transfer and higher use of energy to heat and cool the building.
- Photo 10 is an example of strip window frames that are weathered due to failed seals.
- The sealant surrounding the windows is noted to be at the end of its useful service life with signs of cracking, adhesive and cohesive failure due to prolonged UV exposure.

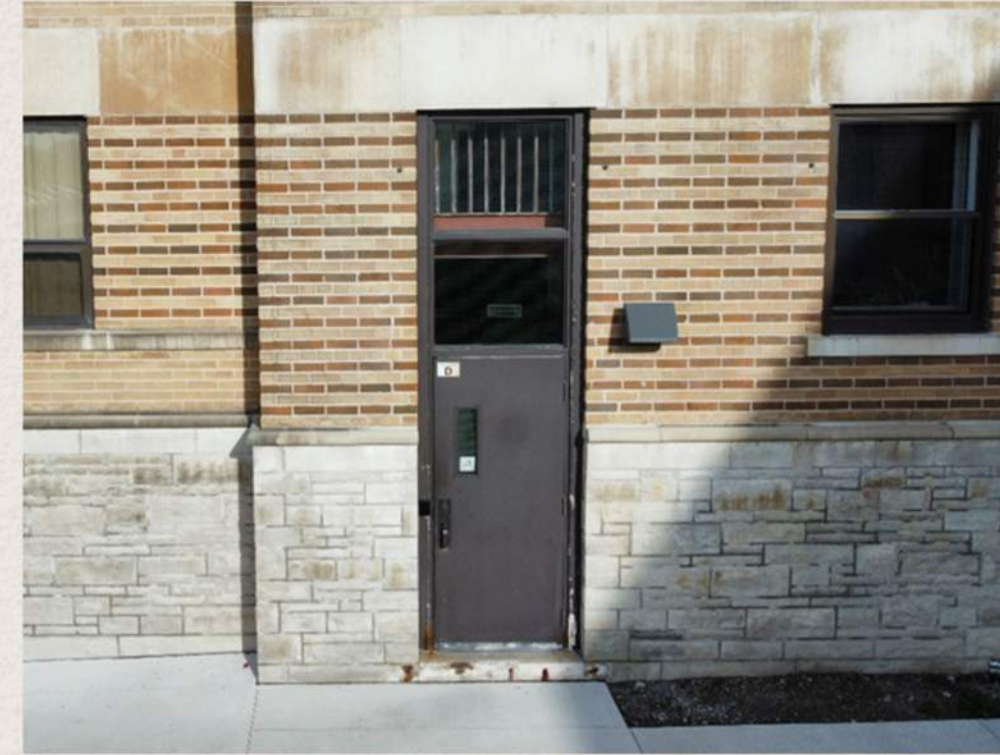
Photo 11

- The exterior doors are steel framed and dated to 1984. The frames and doors are observed to be corroding and have reached the end of their useful service life.
- The existing weather seal surrounding the doors has deteriorated and is not performing to current standards. This causes an inefficiency in the building envelope thermal barrier which allows cold or warm air to enter the building between the doorframe and door.
- The existing doors have a single pane transom window incorporated into the frame as seen in Photo 11. These windows have a poor thermal performance rating and are not up to current construction standards.
- Sealant surrounding the door frames was noted to be deteriorating and at the end of its useful service life.
